EXISTING CONDITIONS MEMORANDUM

FROM: Gene McCarthy, P.E., Project Manager, McFarland Johnson, Inc.

DATE: April 21, 2010

PROJECT: Windham NH Route 111 Corridor and Wall Street Extension Study

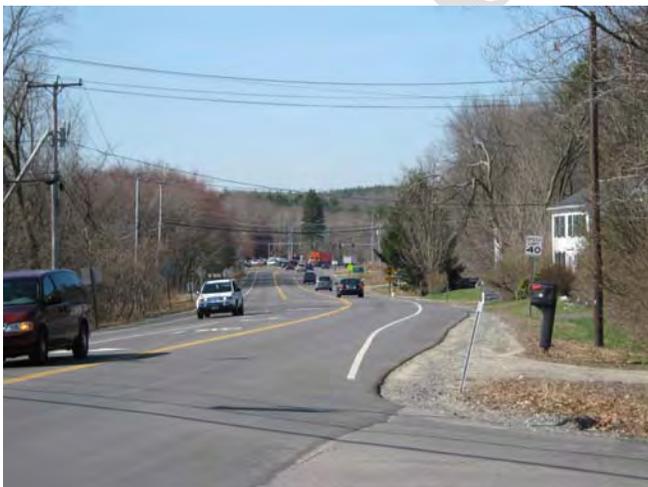
NH Route 111 Looking West from No. Lowell Road

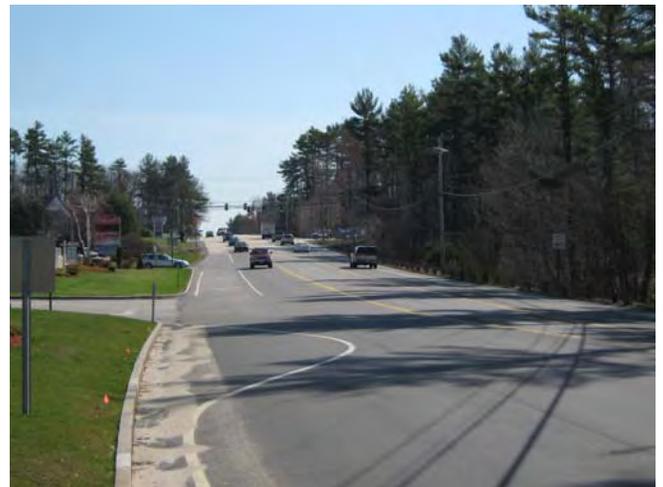
NH Route 111 Looking East from Church Street

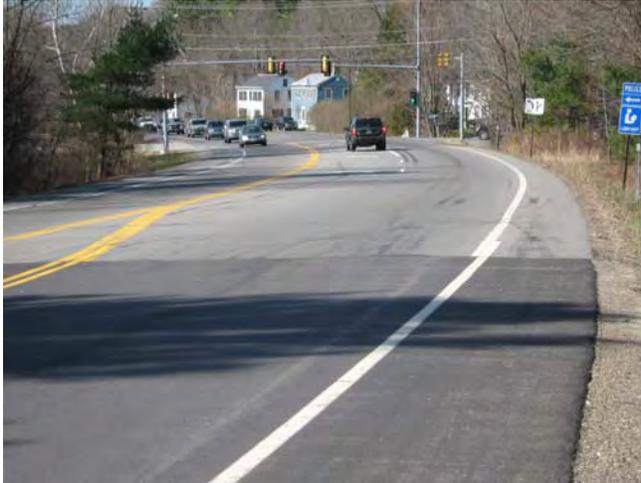
The existing pavement conditions vary as it appears recent road re-surfacing has taken place. The intersection of North Lowell Road and NH 111 has been recently paved and is therefore in good condition. The same is true of the intersection of NH 111 and Church Street and the pavement east towards the shopping plazas. A section of pavement exists between the intersection of Church Street and the intersection of North Lowell Road where the pavement has not been rehabilitated and large cracks have appeared along the shoulders with smaller cracks appearing within the travel way. The pavement along NH 111 west of the North Lowell Road intersection and east of the Hardwood Road intersection appears to be in good condition. Photos of the NH 111 pavement can be seen below. The pavement markings appear to be in good condition along both the new and old sections of pavement. The site distances throughout the corridor are all satisfactory as the roadway is wide.

Section of "Old" Pavement on NH Route 111

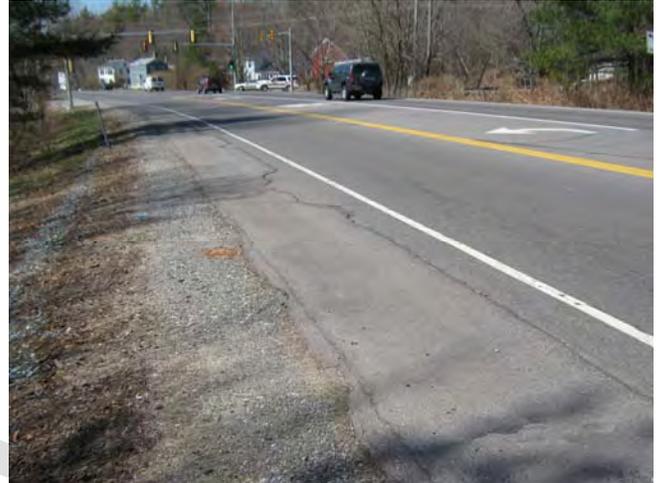
Cracks in Pavement on NH Route 111

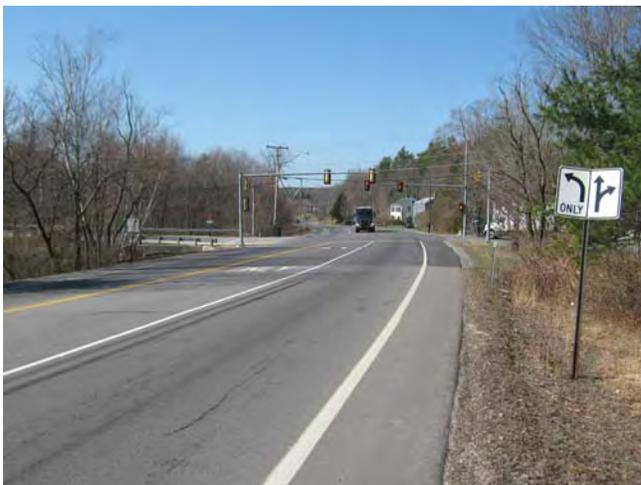
Intersection of NH Route 111 and North Lowell Road

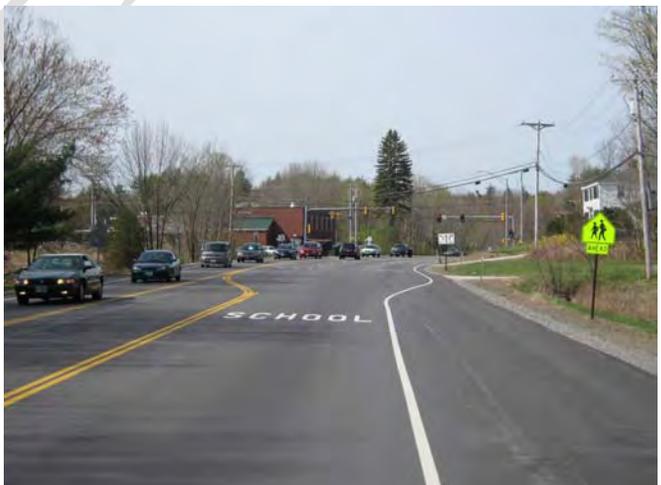
Intersection of NH Route 111 and Hardwood Avenue

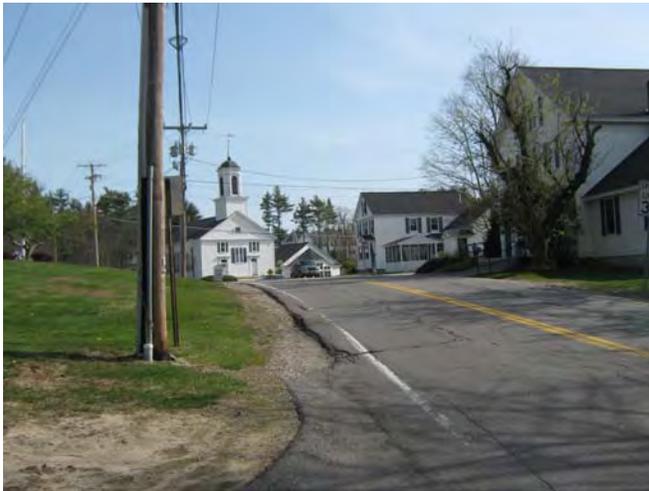
The horizontal and vertical grades are adequate except near the intersection with NH 111. North Lowell Road has an immediate sharp curve and a moderately steep grade north of the intersection with NH 111. Site distances along the southern 600-700 feet, near the town offices, are poor due to the combination of horizontal and vertical curvature. The pavement has significant cracking along the edges and within the travel ways in this area as well.

Limited Sight Distance Exiting Town Offices

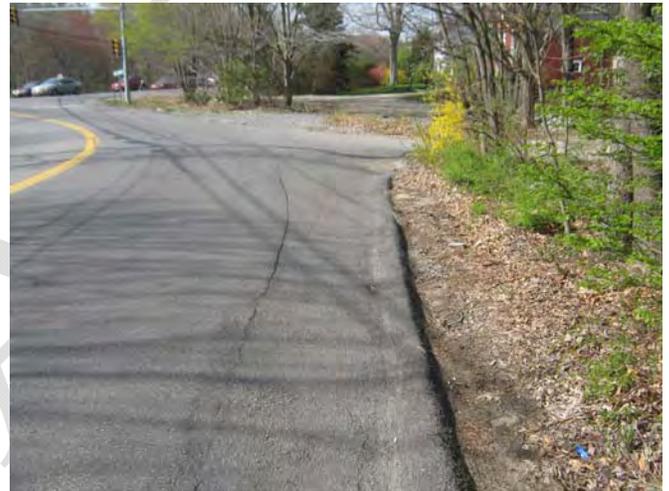
Paved Drainage Ditch, North Lowell Road

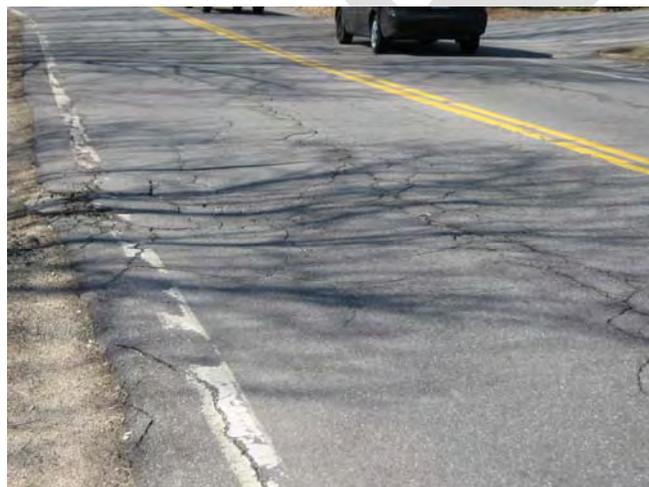
Cracks in Pavement along North Lowell Road

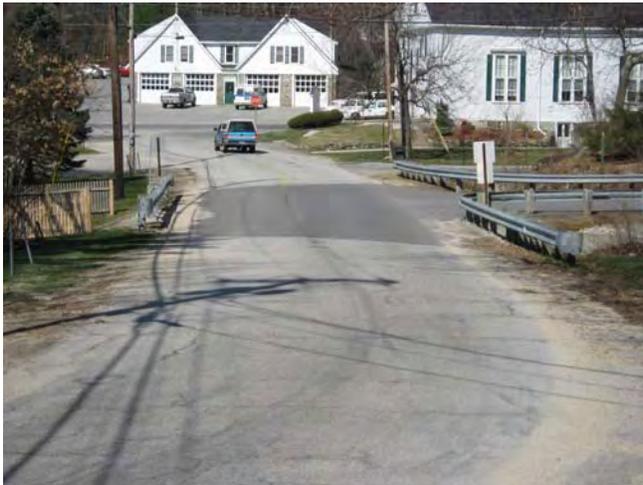
The pavement is in poor condition with significant cracking and frost heaves. There is a new section of pavement where Church Street crosses over Golden Brook. It appears the culvert has been recently improved including new guardrail. Church Street once was a two-way street with traffic permitted to exit on to NH 111, as double yellow pavement markings are still evident down the centerline. There are no sight distance issues created by the geometry of the roadway but it may be difficult to see oncoming traffic heading north on North Lowell Road when attempting to exit Church Street. No sidewalks or bike paths exist along the roadway. There is no posted speed limit along the roadway but it is estimated to be 35 mph.

Looking West Down Church Street

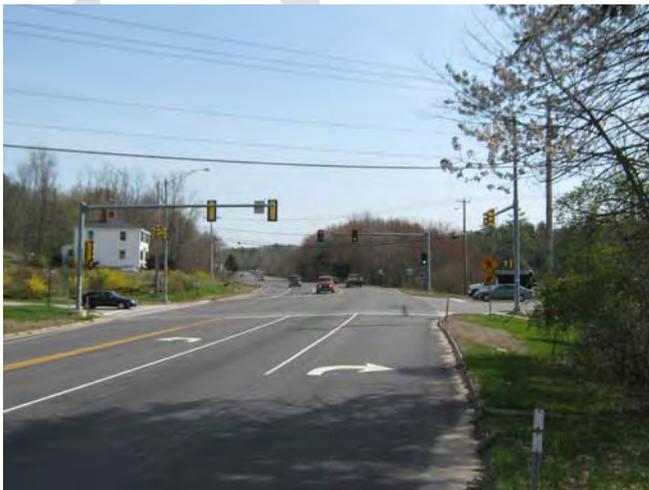
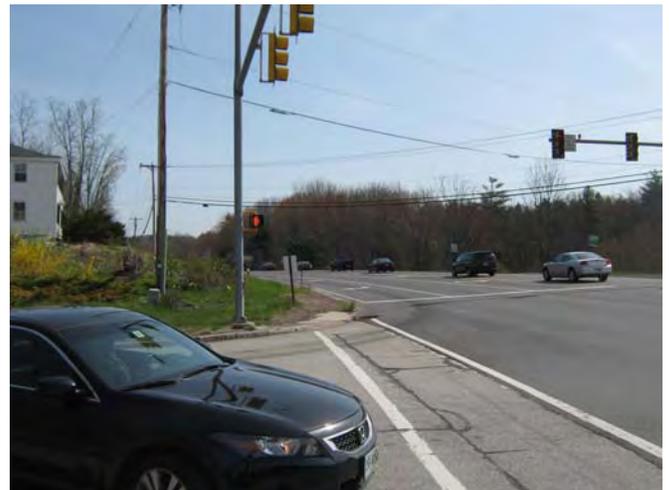
NH 111 is on a horizontal curve as it passes through the intersection, which creates some sight distance issues. Vehicles traveling on NH 111 have an adequate view of the signalized intersection, but not of the roadway beyond. The left turning vehicles are controlled by the signal and therefore do not pose any safety concerns. Vehicles turning right onto NH 11 from South Lowell Road have sufficient views of the highway because the corridor is wide in this area. However, vehicles turning right onto NH 111 from Hardwood Avenue have insufficient sight distance. As a result, no right turns on red are allowed from Hardwood Avenue.

*NH Route 111, Looking East at South Lowell Road and
Hardwood Avenue Limited Sight Distance turning from Hardwood Avenue*

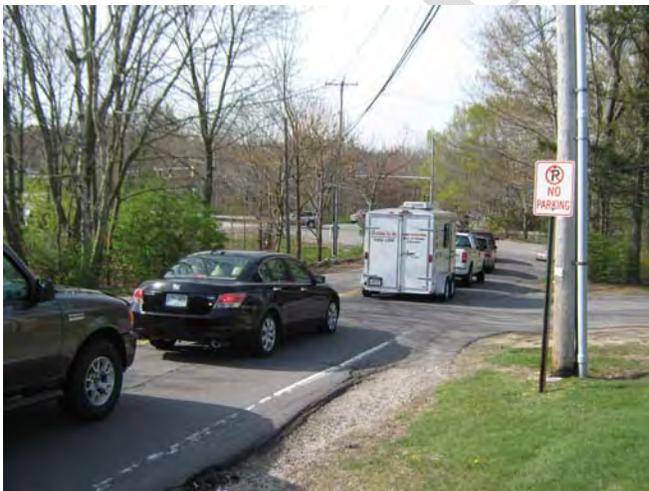
The NH 111/North Lowell Road/Fellows Road Intersection is a 4-way signalized intersection at the Village Center in Windham. Fellows Road is a dead-end local road that provides access to the Windham Police Station, Windham Fire Station, and the Nesmith Library. As the junction between the two commuter routes, NH 111 and North Lowell Road, the intersection experiences significant queuing on North Lowell Road and NH 111. The queue for vehicles making a left turn from North Lowell Road backs up past the right turn lane, prohibiting these vehicles from entering the right turn lane queue.

*Queuing on North Lowell Road near
NH Route 111*

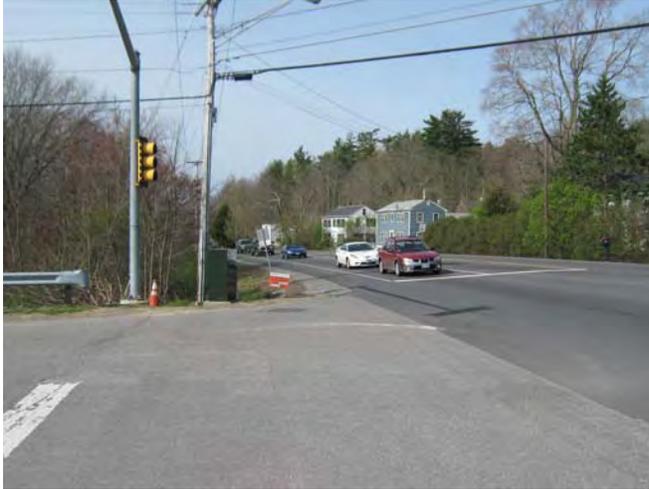
NH 111 is on a horizontal curve as it passes North Lowell Road and Fellows Road, which creates some sight distance issues. Vehicles traveling on NH 111 have an adequate view of the signalized intersection, but not of the roadway beyond. However, vehicles turning on to NH 111 from North Lowell Road and Fellows Road have restricted views of the highway. The left turning vehicles are controlled by the signal and therefore do not pose any safety concerns. Vehicles turning right from Fellows Road have restricted views of NH 111 due to the roadway curvature, roadside signs, and roadside vegetation. This restricted sight distance poses safety concerns for turns made on a red light. Right turning vehicles from North Lowell Road have sufficient sight distance on NH 111.

Limited Sight Distance turning from Fellows Road

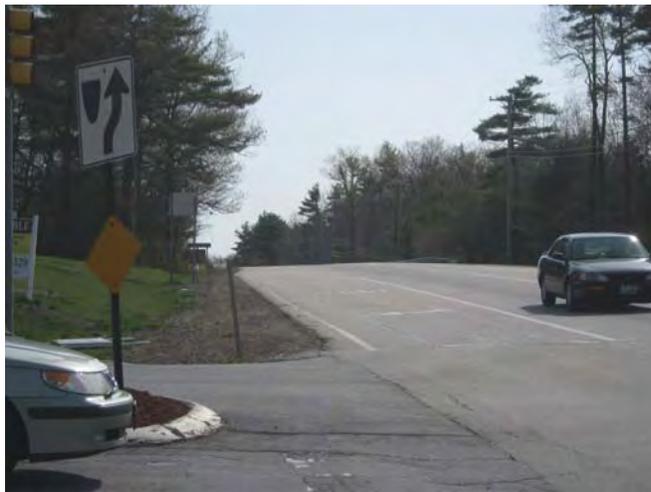
NH 111 through this intersection is a straight roadway with wide lanes and shoulders. However, there is a vertical crest curve east of the intersection that has a high point approximately 400 feet from the intersection. Vehicles traveling westbound on NH 111 have an adequate view of the signal, but not necessarily of the queue of vehicles waiting at the intersection. Vehicles turning right onto NH 111 from the Post Office have sufficient views of the highway. However, vehicles turning right onto NH 111 from the Windham Village Green shopping have restricted views. The sight distance is adequate for the posted speed, however, vehicles often travel above the speed limit and this does pose a potential safety issue.

Limited Sight Distance turning from Windham Village Green Plaza

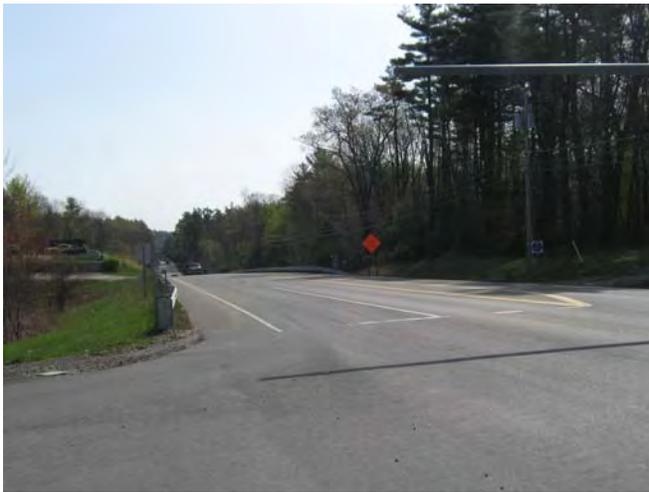
Through this intersection NH 111 is a straight roadway with wide lanes and shoulders. However, there is a vertical crest curve east of the intersection that has a high point approximately 450 feet from the intersection. Vehicles turning right onto NH 111 from Wall Street have restricted views. The sight distance is adequate for the posted speed, however, vehicles often travel above the speed limit and this does pose a potential safety issue.

Limited Sight Distance turning from Wall Street

The NH 111/Wall Street Intersection reported 13 crashes, with four of the crashes resulting in four injuries. A large number of the crashes were rear end collisions which indicate congestion in the area. There were also crashes that occurred while making turning movements and merging with other vehicles. These crashes can sometimes be attributed to improper sight distance or poor intersection design. Specifically, when traffic is exiting Wall Street and looking towards the east there is a crest vertical curve that may hinder the ability to see approaching traffic. Combining this poor sight distance with the high rate of speed in this area creates an unsafe right hand turn for vehicles stopped at the red light exiting Wall Street. Prohibiting the right turn on red movement when exiting Wall Street may reduce the crash rate at this intersection.
